Manhole Inspection Summary

Manhole # S17K__001MH

Page 1 of 3

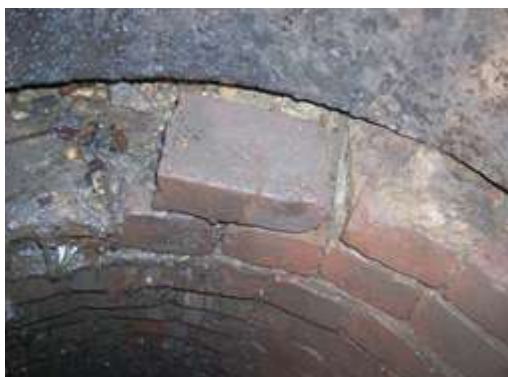
Defect 2

Condition: ☐ Sound ☐ Cracked ☐ Root Intrusion ☒ **Loose Brick** ☐ Deteriorated

loose corbel bricks

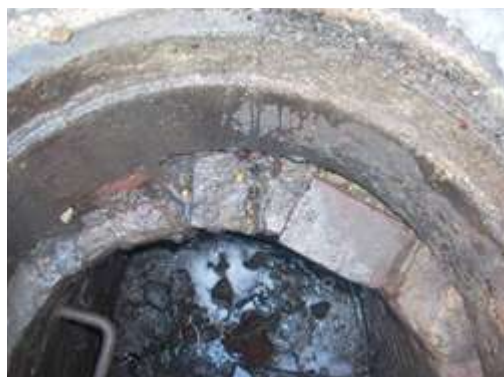
Defect 1

Frame Offset: **4** (in.) Condition: ☒ Sound ☐ Cracked ☐ Leaks

frame offset

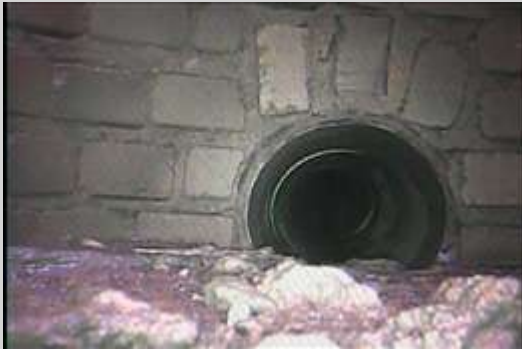
12 O'Clock Outflow

Comments **O12 has flow due to inflow from the alley.**
